ENGINEERING INVESTIGATION REPORT

STEPHANIE AND MICHAEL WADSWORTH v. WALMART, INC. AND JETSON ELECTRIC BIKES, LLC

Case No.: 2:23-CV-00118
Location: 1620 Highway 374, Green River, Wyoming
Date of Loss: February 1, 2022
AEI Project No.: 15082

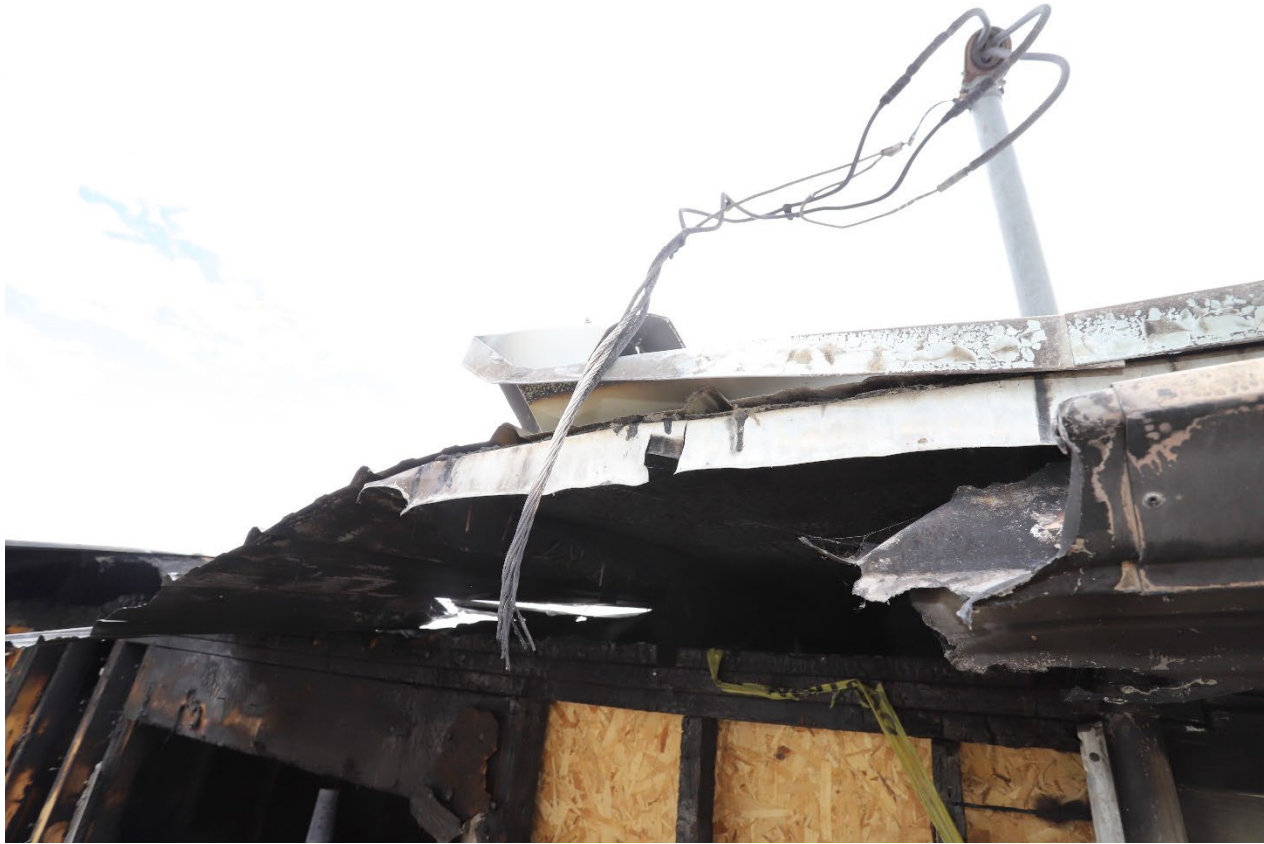
The joint site inspection was continued on August 2 and 3, 2022, with additional parties represented. Electrical service to the Residence was provided via an overhead service triplex from a utility pole located to the southeast of the Residence to a weatherhead and meter base located just south of the front door on the east exposure. The service triplex was severed several feet prior to where it connected to the weatherhead (Figure 2). The severed ends of the aluminum conductors comprising the service triplex had been melted. The weatherhead was located to the north of the remnants of the Smoking Shed and adjacent to an area of the roof that was consumed in the fire; however, there was no direct fire damage to the weatherhead or the meter base. In its installed position, the service triplex would have ran directly over the Smoking Shed.

Figure 2. Weatherhead and severed service triplex (15082 BNS 2-221).

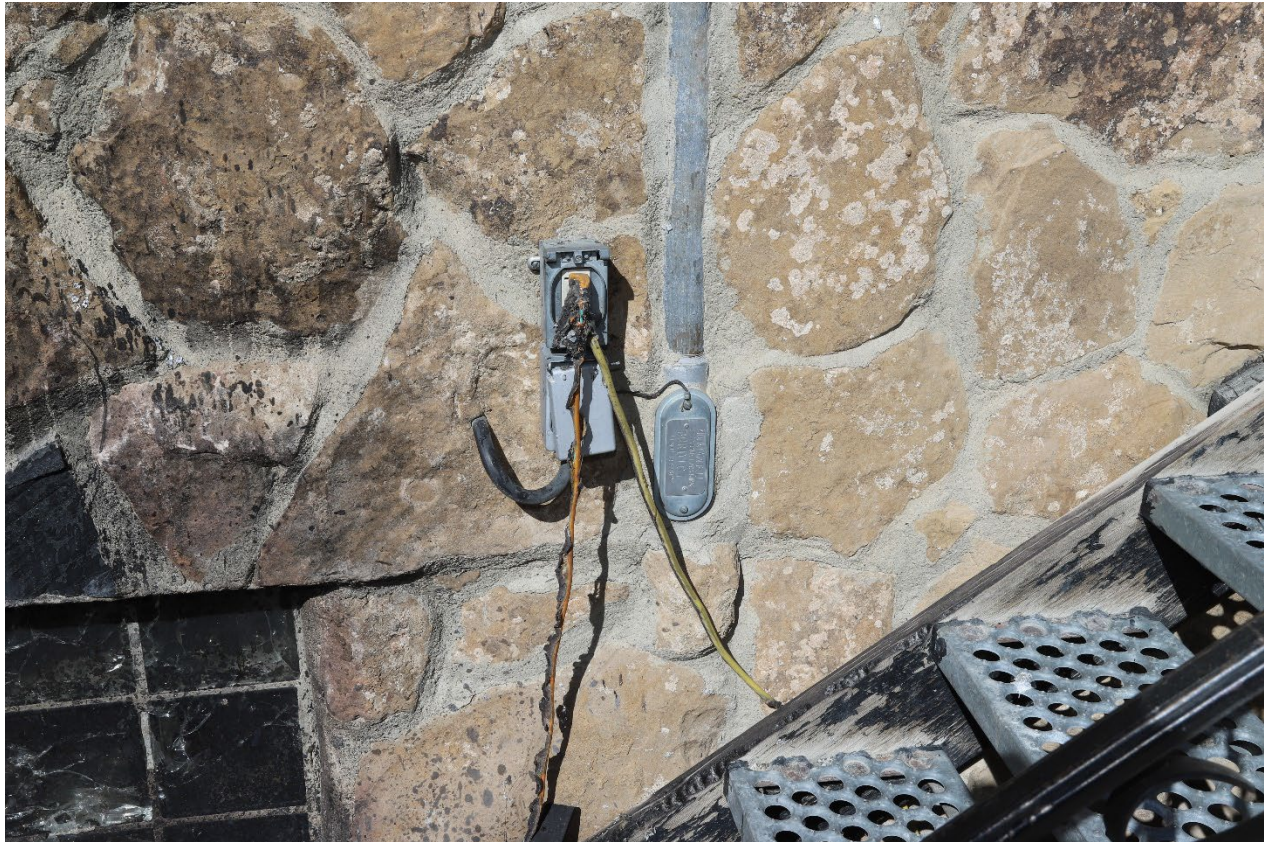
The main electrical panel was located in the basement below the meter base. There was no direct fire damage to the main panel or the area of the basement in which it was installed. A single-pole, 15-ampere, branch circuit breaker in position 1 (labeled “North west Bedroom”) in the main panel fed the receptacles and luminaires in Bedroom #4. A two-pole, 30-ampere, branch circuit breaker installed in positions 16 and 18 (labeled “Outside Porch Power”) in the main panel fed a NEMA 10-50R receptacle and a duplex NEMA 5-15R receptacle on the east exterior of the Residence via an 8/3 SO cord (Figure 3).

Figure 3. A NEMA 10-50R receptacle and a duplex NEMA 5-15R receptacle on the east exterior of the Residence. Two extension cords are plugged into the duplex receptacle (15082 BNS 1-032).

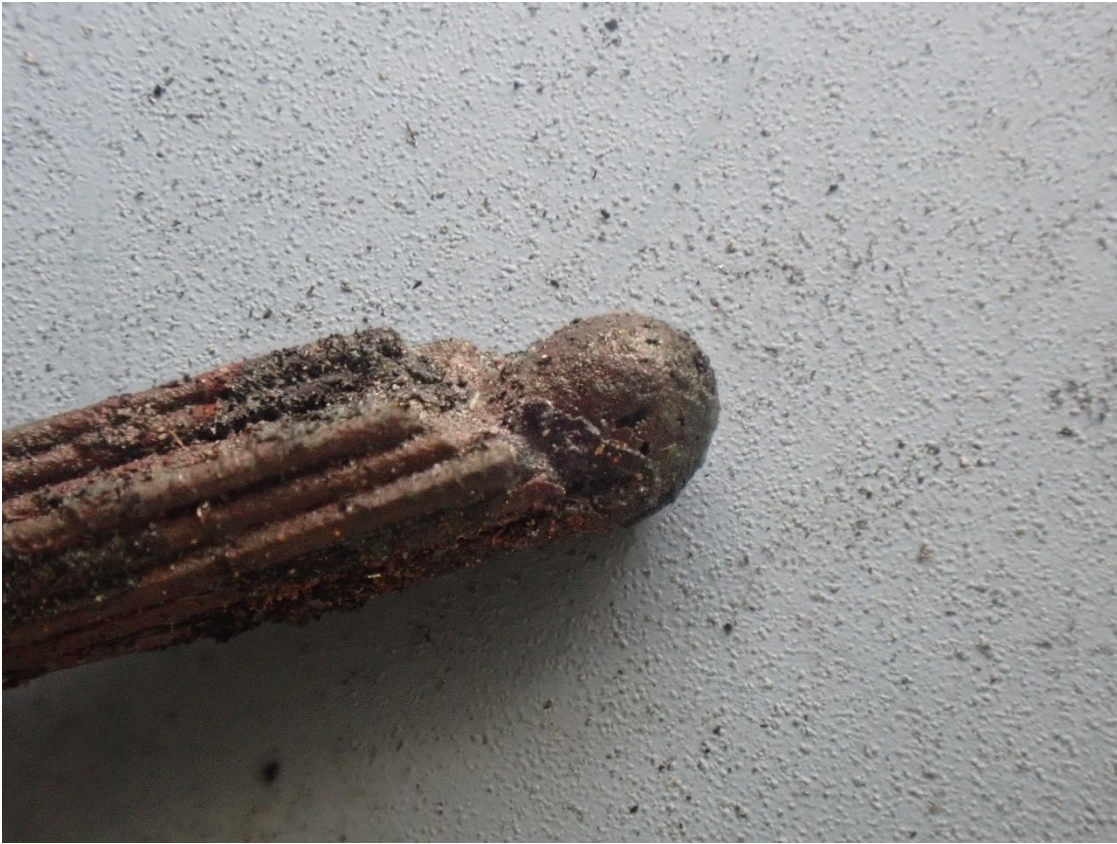
Two extension cords (one orange and one yellow in color) were plugged into the duplex receptacle on the east exterior of the Residence. The yellow extension cord ran to a metal post approximately 20 feet to the east of the Residence where it was connected to a splitter. Plugged into the splitter was a cord leading to an electrical box mounted on the post, a shore power cord for a camper trailer parked near the post and a second yellow extension cord which fed a bird bath de-icer in a polymer barrel of water located to the south of the remnants of the Smoking Shed on the east exterior of the Residence. The orange extension cord ran to the melted and resolidified mass of polymer in the location where the Smoking Shed once stood. Fragments of stranded copper conductors were present in and around the remnants of the Smoking Shed, some displaying visual evidence of electrical arcing (Figure 6). The remnants of the Smoking Shed and surrounding debris were preserved for further examination.

Figure 6. Evidence of electrical arcing on conductor found outside structure at Smoking Shed (15082 BNS 3-006).

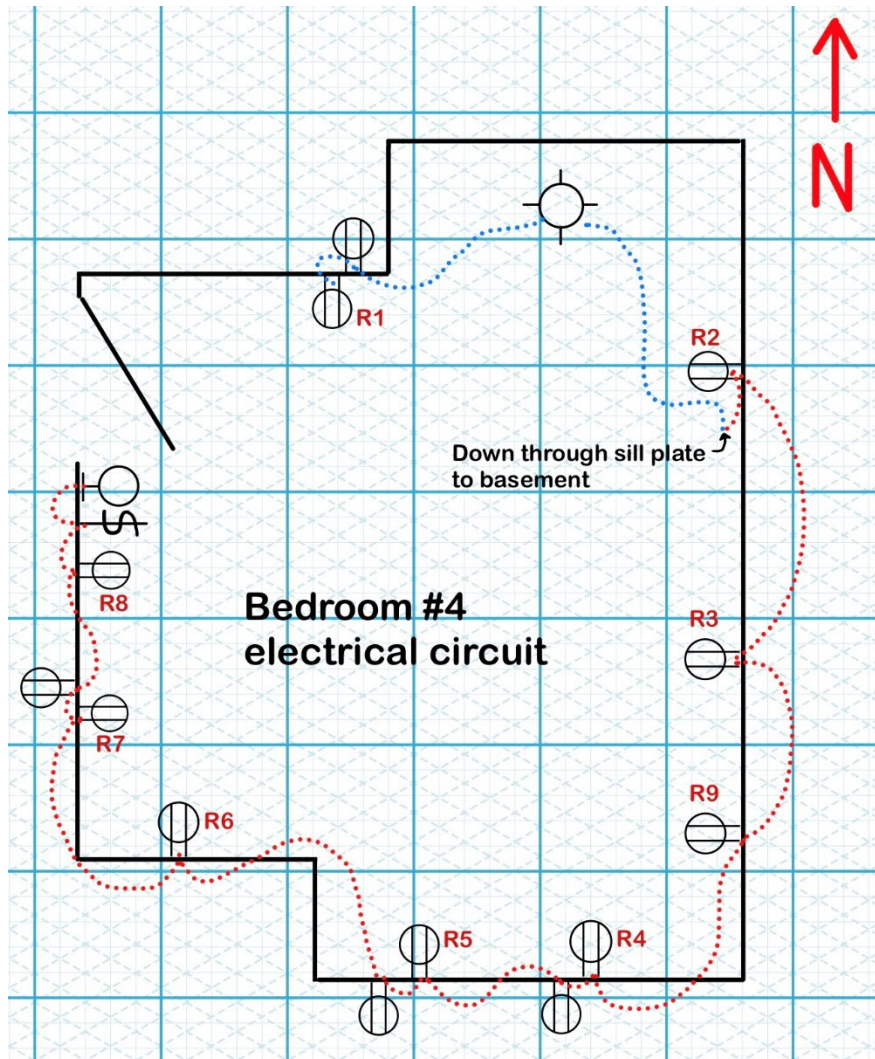
The entire branch circuit from within Bedroom #4 was traced and preserved for further examination. The branch circuit that supplied power to Bedroom #4 was split into two separate non-metallic (NM) cables in the basement of the Residence. These two NM cables were marked with red and blue paint respectively at the locations where they were cut in the basement of the Residence during the collection of artifacts during the joint scene inspection. The NM cable marked with blue paint fed the northern portion of Bedroom #4 and the NM cable marked with red paint fed the southern portion of the room. The duplex receptacles in Bedroom #4 were designated R1 through R9 during the joint site inspection prior to removal from the structure (Figure 7).

Figure 7. Diagram of the electrical branch circuit in Bedroom #4.

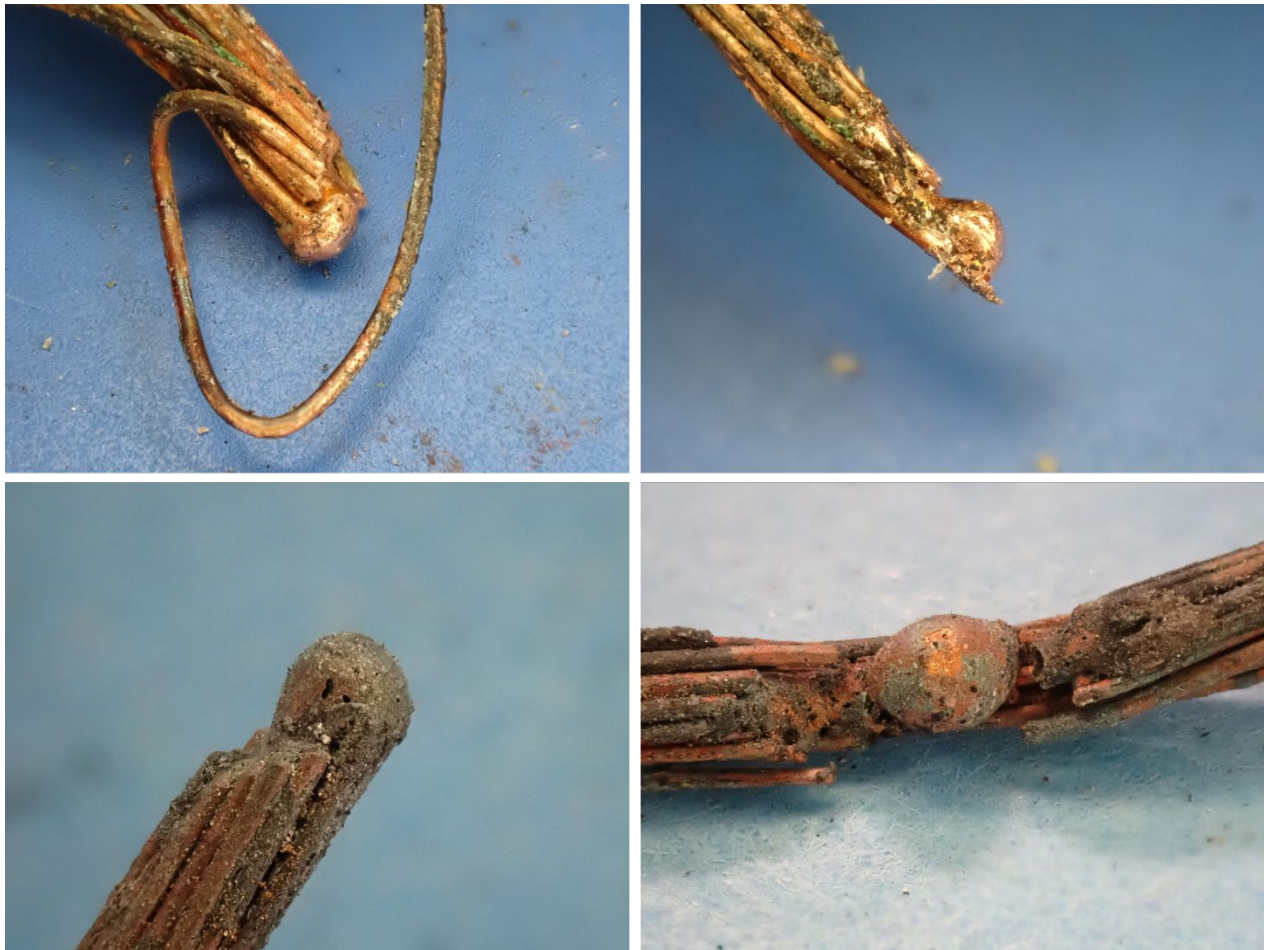
A laboratory examination of the artifacts preserved from the fire scene was conducted at the Palmer Engineering and Forensics facility in North Salt Lake City, Utah on October 30 and 31, 2023. Debris collected from the exterior of the Residence in the area of the Smoking Shed including the mass of melted and resolidified polymer that remained of the Smoking Shed was examined. Numerous stranded copper conductor fragments were found that contained evidence of electrical arcing (Figure 9).

Figure 9. Some of the instances of evidence of electrical arcing on conductors found in or around the Smoking Shed (15082 BNS 7-014, 7-106, 7-045, 7-066).

In the subject fire, stranded copper conductors present in the Smoking Shed, either extension cords or appliance (space heater) cords, or both, displayed evidence of electrical arcing proving that those cords were energized at the time that fire was present in the Smoking Shed. The entire branch circuit that supplied power to the receptacles and luminaires in Bedroom #4; however, contained no evidence of electrical arcing despite the electrical insulation being completely burned away on portions of the circuit. The insulation on the branch circuit wiring to the receptacle immediately adjacent to the location where the hoverboard was found was completely consumed in the fire; however, there was no evidence of electrical arcing on these conductors. The lack of any evidence of electrical arcing occurring in the fire damaged branch circuit conductors located in Bedroom #4 and the lack of any tripped circuit breakers in the electrical panel for the Residence (including the branch circuit breaker for Bedroom #4) was consistent with the branch circuit supplying power to Bedroom #4 being de-energized at the time that the fire attacked the branch circuit conductors in the bedroom.

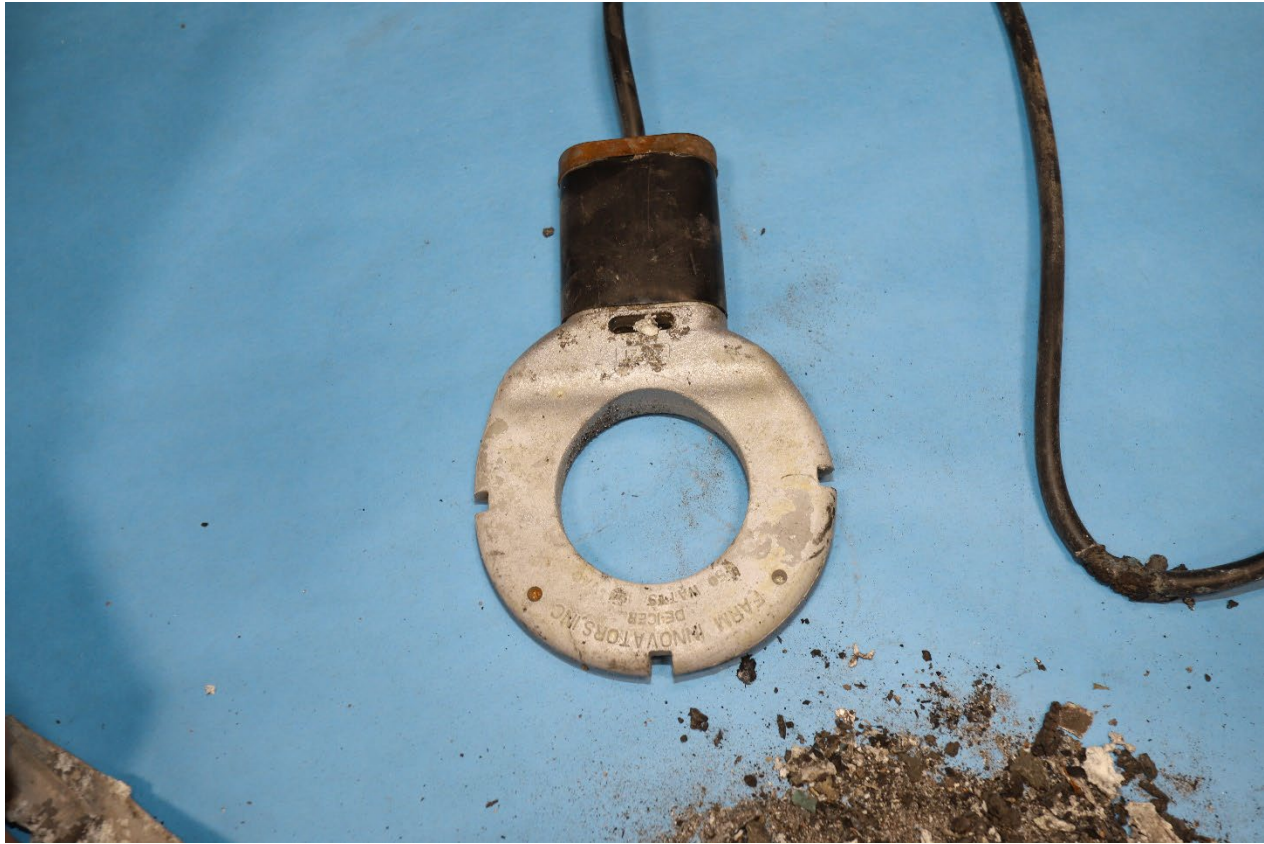
The power cord for bird bath de-icer and the yellow jacketed extension cord it was plugged into were both thermally damaged in the area where the cords were located near the Smoking Shed. The body of the bird bath de-icer was intact and not fire damaged (Figure 10). There was no evidence of a failure of the bird bath de-icer.

Figure 10. Bird bath de-icer not fire damaged (15082 BNS 5-054).

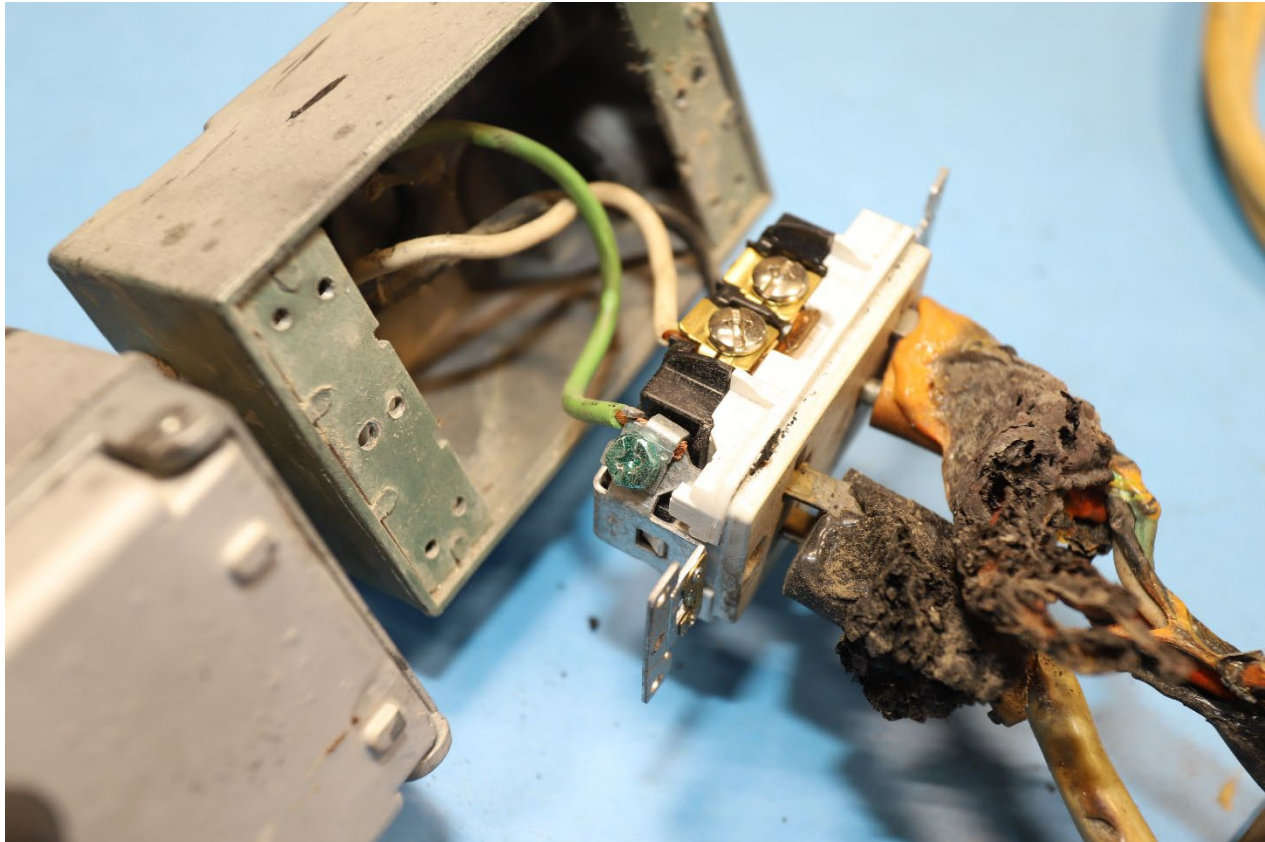
The 50-ampere and duplex 20-ampere receptacle from the east exterior of the Residence were opened for examination. The 50-ampere receptacle was fed by an 8-gauge, 3 conductor (8/3), type SO cord from a two-pole, 30-ampere, branch circuit breaker in the main panel. The duplex 20-ampere receptacle was fed by smaller gauge conductors tapped into the screw terminals on the 50-ampere receptacle. The grounding tab on the duplex receptacle was wired to the metal switch box that housed the receptacle and an uninsulated stranded conductor exited the switch box through a drilled hole. The other end of the uninsulated conductor had been bolted to a metal conduit connected to the meter base at the Residence. Neither of the receptacles were fire damaged. Two extension cords, a (second) yellow jacketed cord, and an orange jacketed cord were plugged into the duplex receptacle (Figure 11). The extension cord jackets and the plug ends were thermally damaged from the outside. There was no evidence of a failure at the receptacles.

Figure 11. Two extension cords plugged into the duplex receptacle on the east exterior of the Residence (15082 BNS 5-099).

The 20-ampere, duplex receptacle on the east exterior of the Residence was tapped off of a 30-ampere branch circuit. The extension cords plugged into the duplex receptacle that ran to the Smoking Shed were a combined length of approximately 50 feet or more in length and constructed of stranded copper conductors that were far smaller than required for service on a 30-ampere branch circuit. The overcurrent resulting from electrical arcing at or near the far end of those long, smaller conductors would be limited by the impedance of the circuit and the 30-ampere branch circuit breaker could not be expected to reliably trip when that arcing occurred.

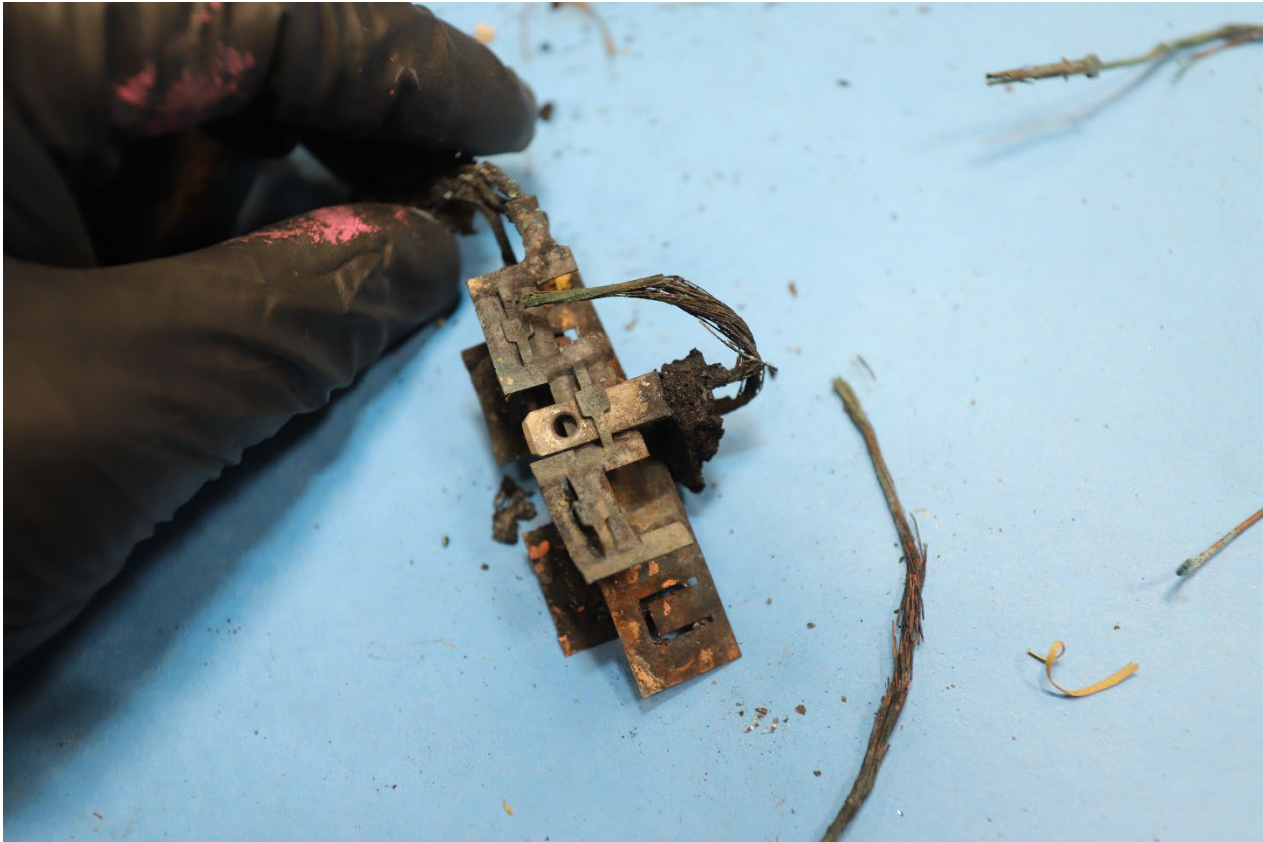
A three-position power tap from the end of an extension cord with two plug blades present in one of the positions recovered from the area of the Smoking Shed was examined (Figure 13). There was no evidence of electrical arcing at the plug connections nor any other evidence of a failure of the connections. The stranded copper conductors of the power tap were mechanically fractured several inches from the receptacle.

Figure 13. Three position power tap from the end of an extension cord with two plug blades from an unknown device still attached (15082 BNS 5-129).

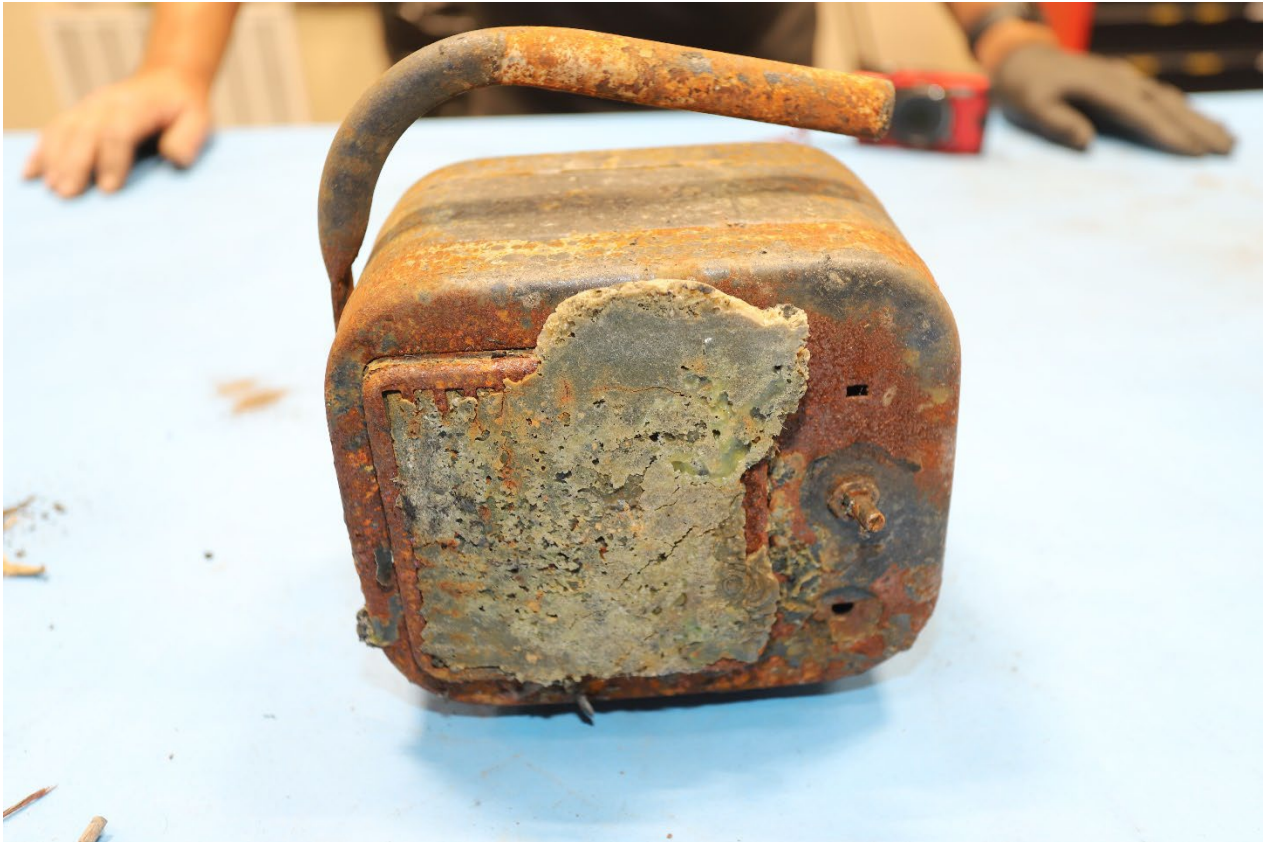
The fire damaged remnants of a fire damaged electric space heater found in the area of the Smoking Shed were externally examined (Figure 14). The conductors of the power cord were fractured at the location where they entered the body of the heater. A melted and resolidified mass of polymer filled the air outlet of the space heater. No destructive examination of the space heater was performed.

Figure 14. Fire damaged space heater (15082 BNS 5-129).
